SUBJECT **Wiring Harness Damage Causes Various Electrical System Faults**

MODEL E38 (7 Series) Vehicles produced up to February 21, 2000

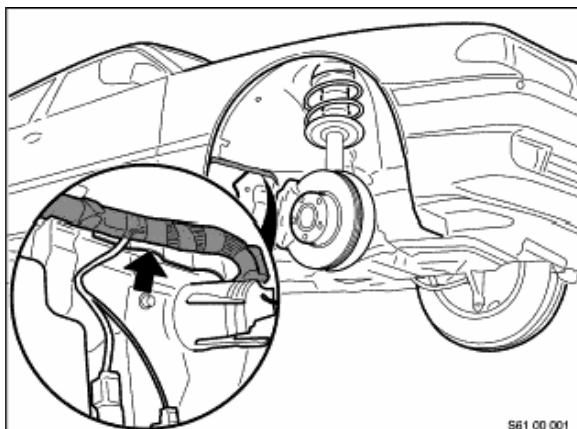
SITUATION Various faults can occur in the vehicle electrical systems. In some cases, the faults only occur intermittently. The warning lights or check control displays of the affected systems may be activated after the engine is started or while driving.

The wiring harness can be damaged by the metal panel (arrow) in the front-right wheel housing

1. Remove the front right wheel and inner wheel housing trim.
2. Expose the wiring harness (see illustration) from its retainers.
3. Remove the wiring harness tape in the area described (arrow).

4. Expose and carefully check the wires for damage to the insulation. If no damage can be detected, proceed with step 7.
5. Disconnect the vehicle battery.
6. Repair any damaged wires (refer to repair instructions 61 13... - Handling cables and crimping contacts).
7. Before reattaching the harness, wrap it along its length with insulating tape.
8. In addition, secure a foam support to the wiring harness with cable ties to prevent further wiring harness damage.
9. Secure the wiring harness so that it is tightly attached and free from the effect of vibration.
10. Reinstall the wheel housing trim and wheel.
11. Clear the fault memory.
12. Make a red mark next to the emission label - see illustration above.
